SCLF Annual Conference 2024

Challenges of complex NAPL characterisation and developing a remediation strategy within condensed development timescales

Helen McMillan, Associate Technical Director

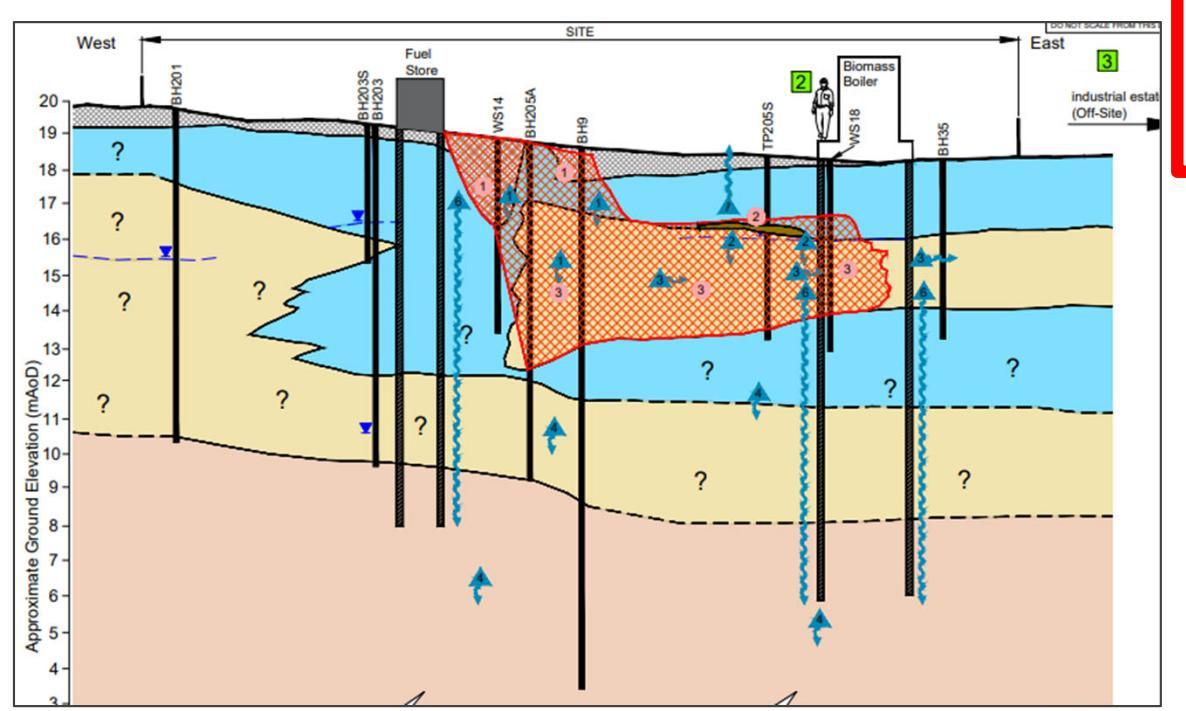
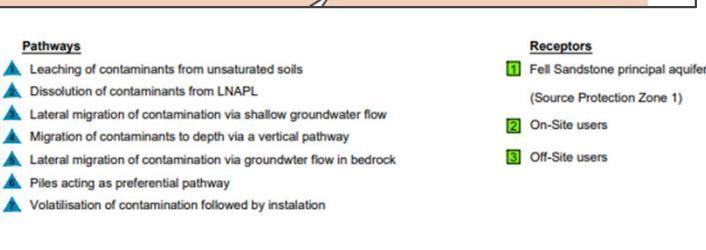
Hydrogeological Conceptual Site Model

Potential contaminant sources

On-Site Sources

Hydrocarbons observed and concentrations detected in unsaturared and saturated zone soils

- Light non aqueous phase product (LNAPL)
- (3) Hydrocarbon concentrations detected in shallow groundwater

- RCL1: dissolution of **NAPL** to shallow groundwater within the granular Till at TP205s and potentially extending to BH7 and BH9
- RCL2: migration of dissolved phase contaminants (hydrocarbons) within shallow groundwater at TP205s (associated with NAPL source) to depth to the principal bedrock aquifer and associated possible abstractions
- RCL3: inhalation exposure of future on and off-site users to vapour from groundwater at TP205s associated with NAPL source

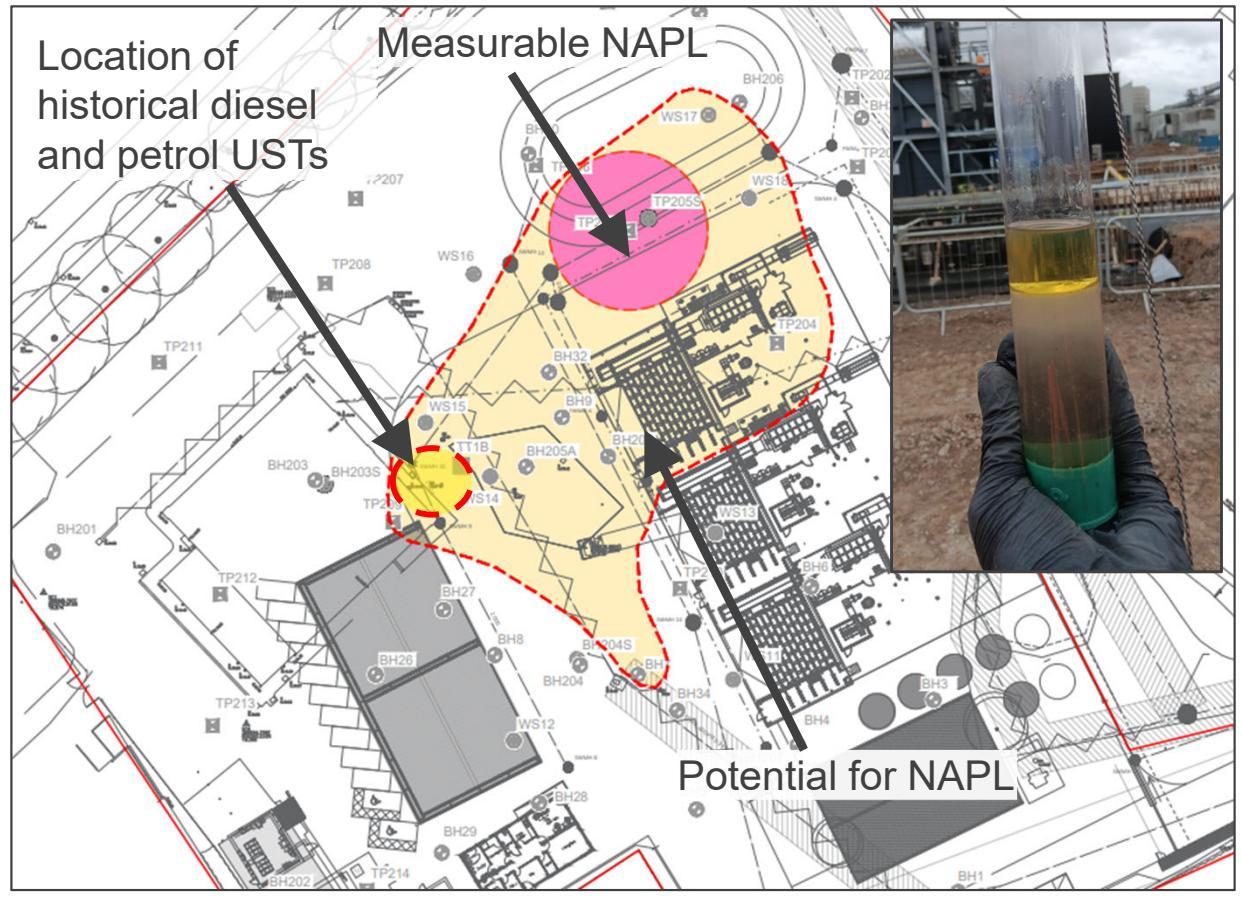
Key risk areas and uncertainties

Uncertainties:

- Extent, mobility and chemistry of NAPL source
- Presence of unsaturated soil source
 - Thickness/effectiveness of intermediary cohesive clay layer in providing a barrier to vertical migration
- Limited SI coverage in area of boilers
- Limited groundwater sampling

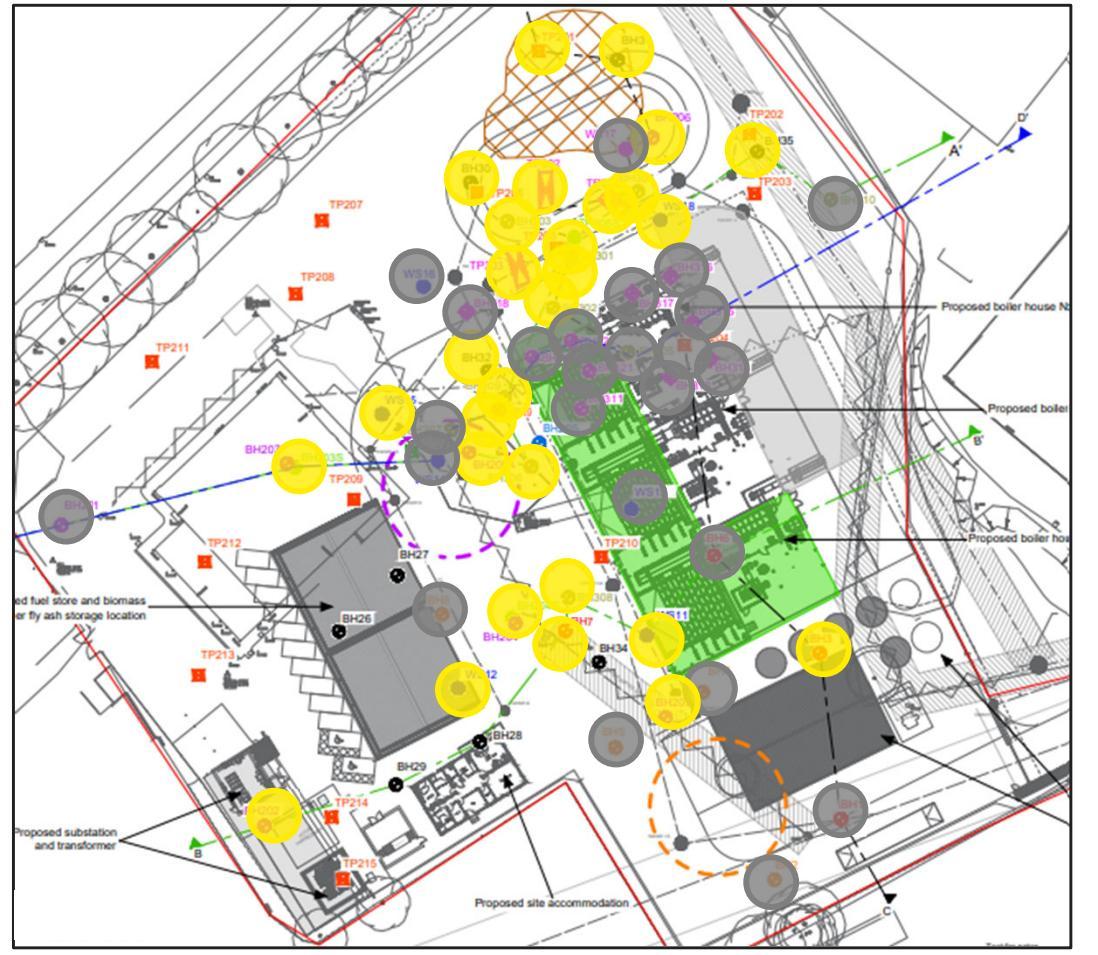
Ground conditions – granular till distribution

Intermediary granular Till layer present >1 m thickness

Intermediary granular Till layer absent or <1 m thickness

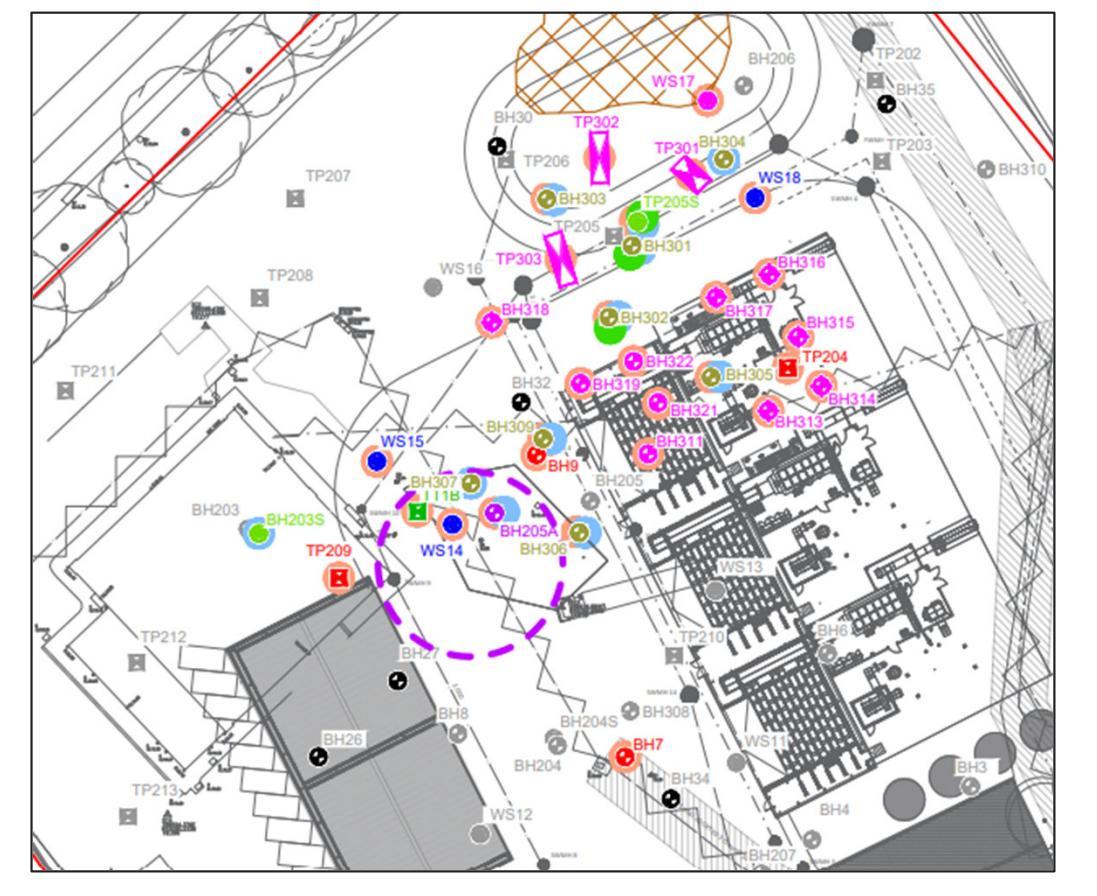
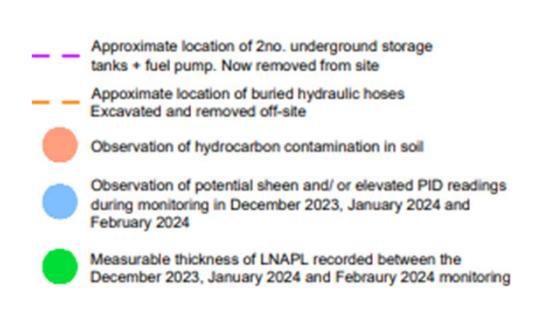
Observations of contamination during investigation and monitoring

Observations of contamination typically restricted to the shallow granular till horizon and correlate with presence of groundwater

Correlates with soil testing results indicating hydrocarbon impacts are limited to saturated zone

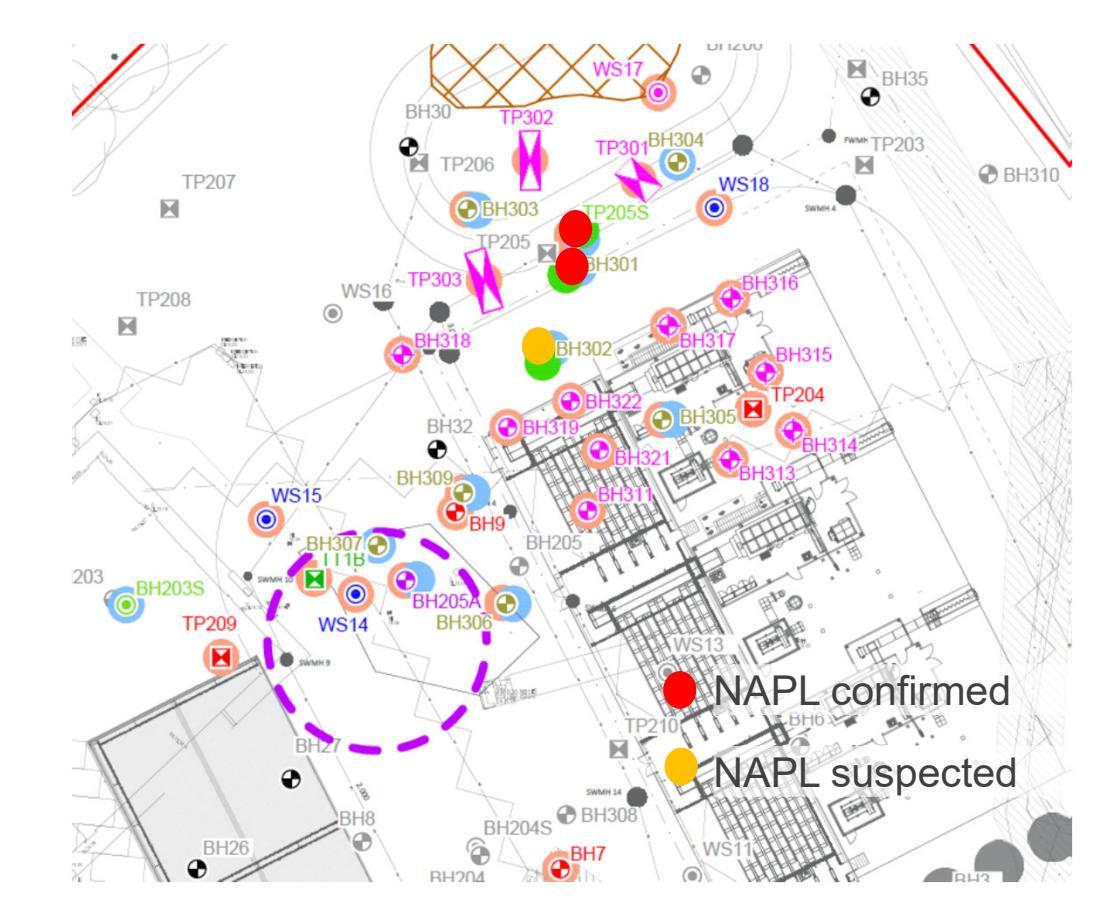
Direct and indirect evidence for LNAPL

Groundwater monitoring - 5 rounds (Dec-Feb), measured LNAPL thickness

- BH301: 0.3-13.1 cm, mean 3.0 cm
- TP205s: 0.2-0.3 cm

BH302: 0.1-0.3 cm, <0.01 since 15/01

PID > 500 ppm during GWM:

BH301, TP205s only; area reducing over GWM1-3

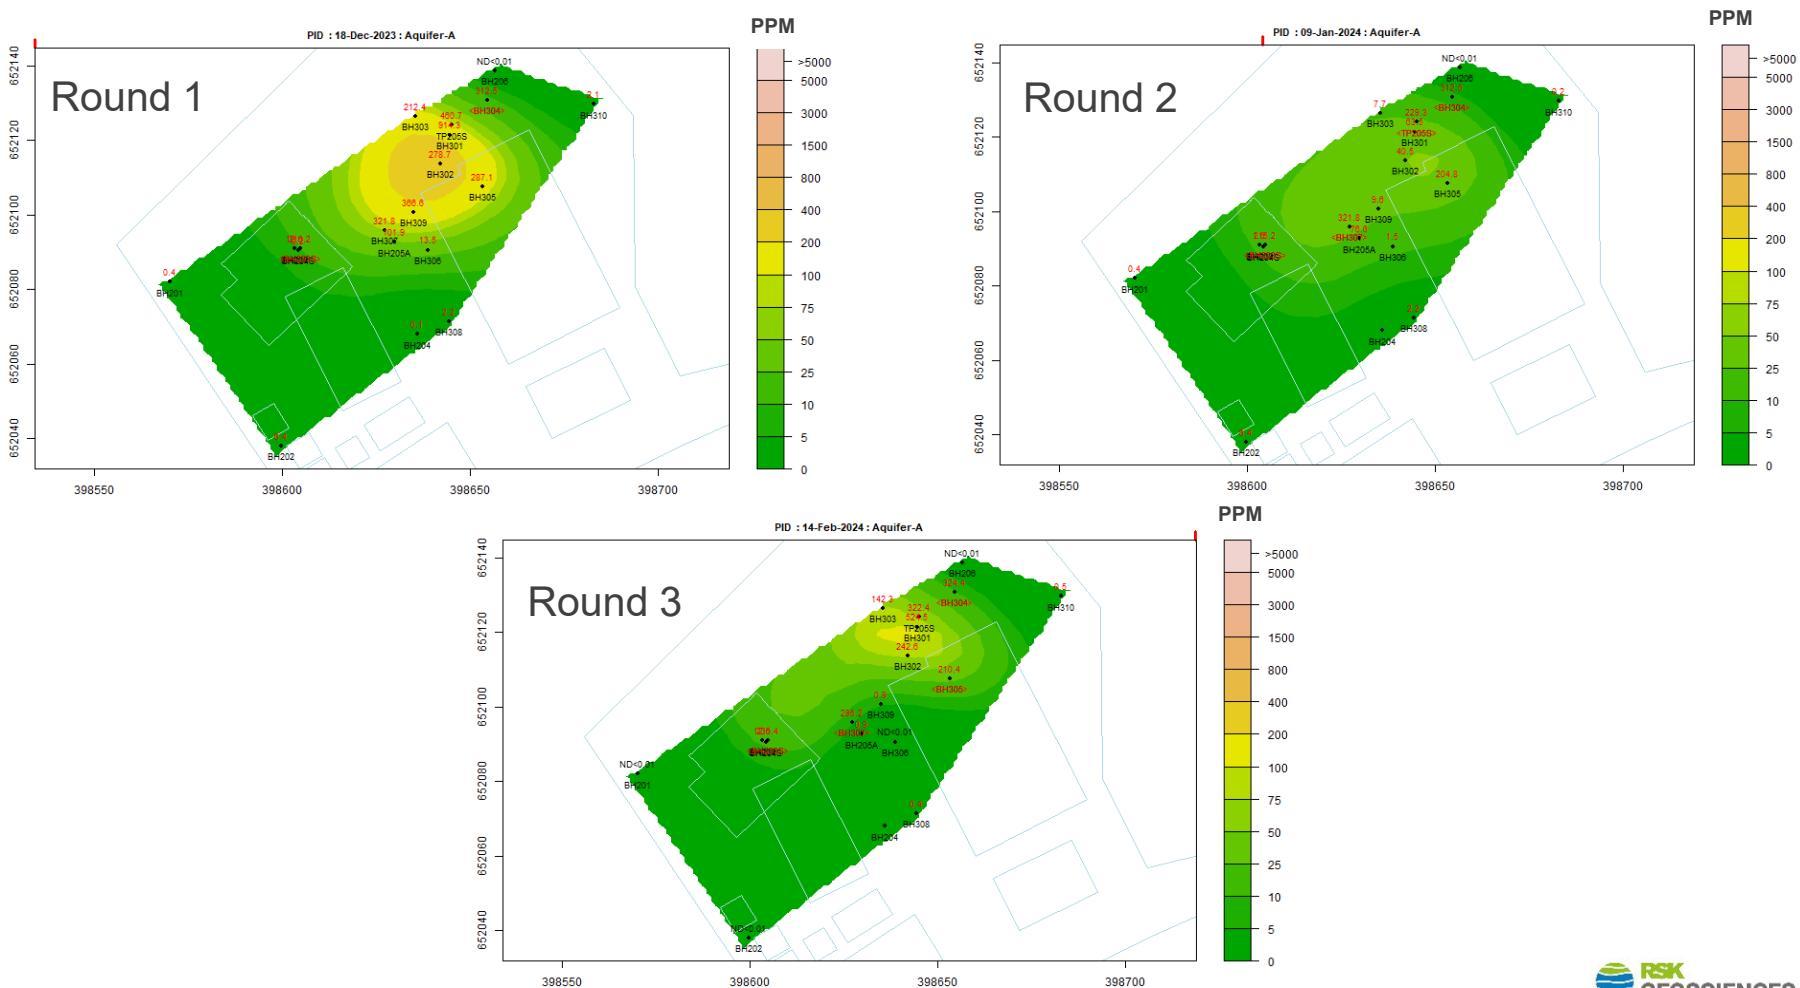
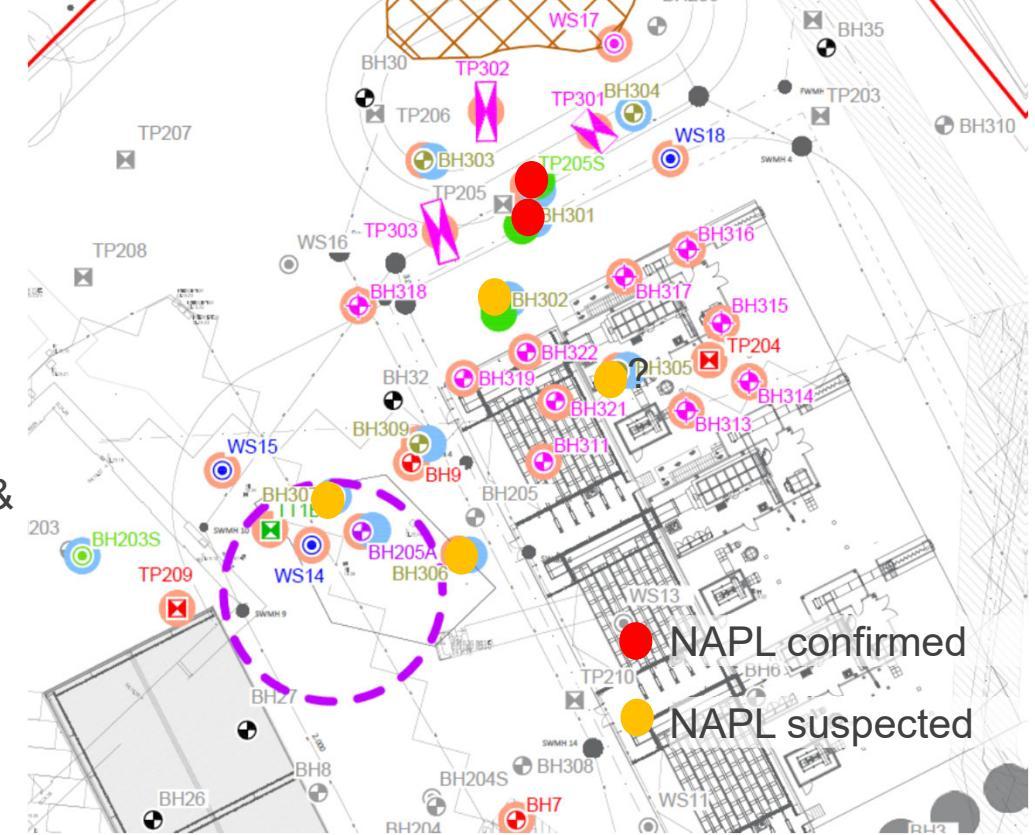
PID spatial plots

Groundwater monitoring - 5 rounds (Dec-Feb), measured LNAPL thickness

- BH301: 0.3-13.1 cm, mean 3.0 cm
- TP205s: 0.2-0.3 cm
- BH302: 0.1-0.3 cm, 0 since 15/01

PID > 500 ppm during GWM:

BH301, TP205s only; area reducing over GWM1-3

Groundwater lab data >10% pure phase solubility & NAPL based effective solubility (BH301 sample):

BH302, BH305 (R1 only), BH306, BH307

Groundwater lab data benzene >3 mg/l, BTEX >20 mg/l:

BH302, BH305 (R1 and R3)

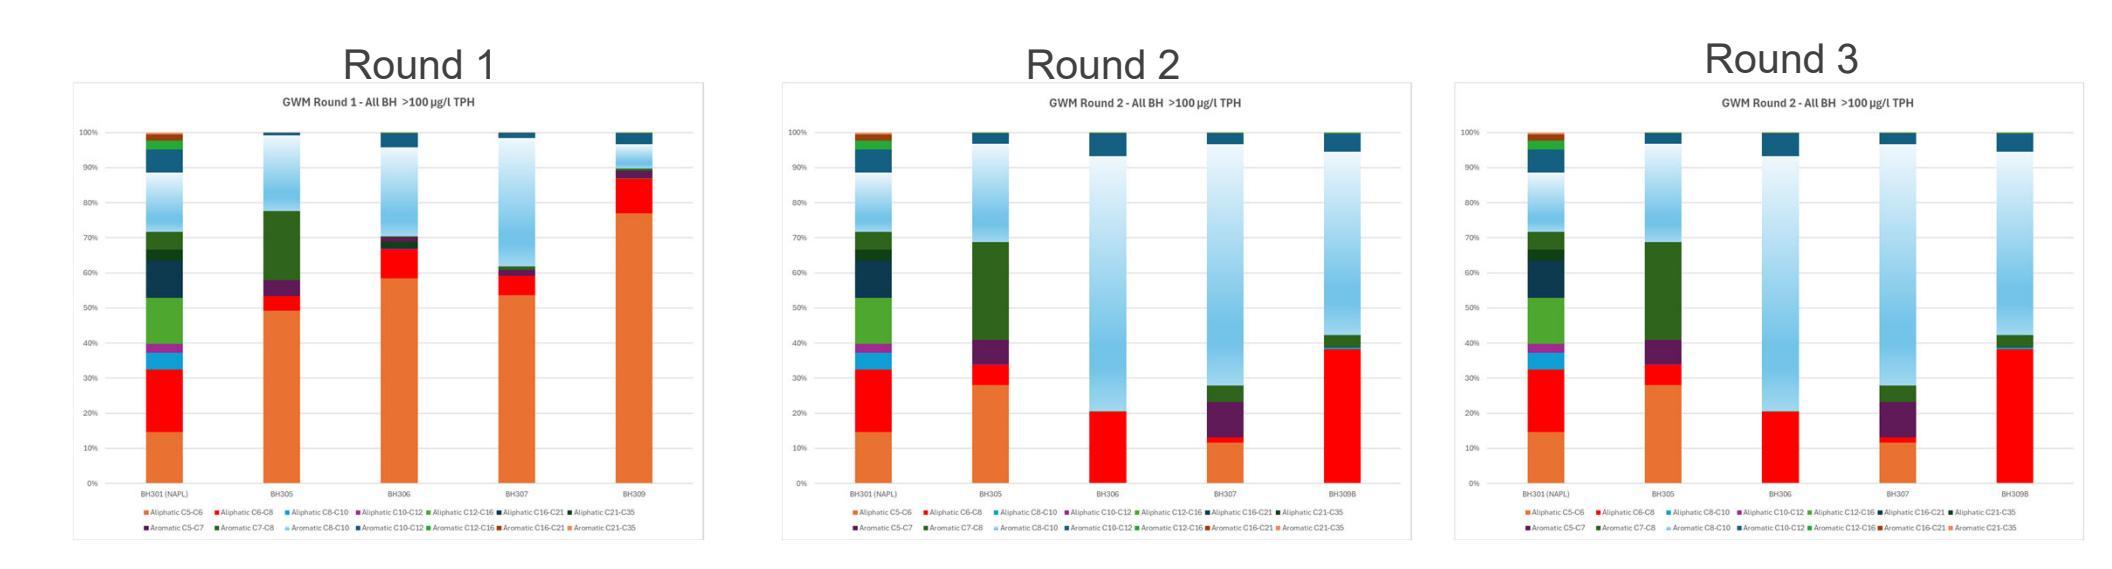
TPH Concentration Profiles in Groundwater Samples

- BH301 LNAPL sample range of aliphatic and aromatic dominated by >C5-C10
- Groundwater samples poorly correlated with LNAPL sample dominated by the most mobile and soluble light aliphatic and aromatic fractions
- Evidence of a moving front of dissolved phase impact
- NAPL does not extend beneath boiler house 1
